STREAM CHANNEL STABILITY

APPENDIX D

BANK STABILITY AND BANK MATERIAL PROPERTIES IN THE BLUFFLINE STREAMS OF NORTHWEST MISSISSIPPI

USDA Sedimentation Laboratory
Oxford, Mississippi

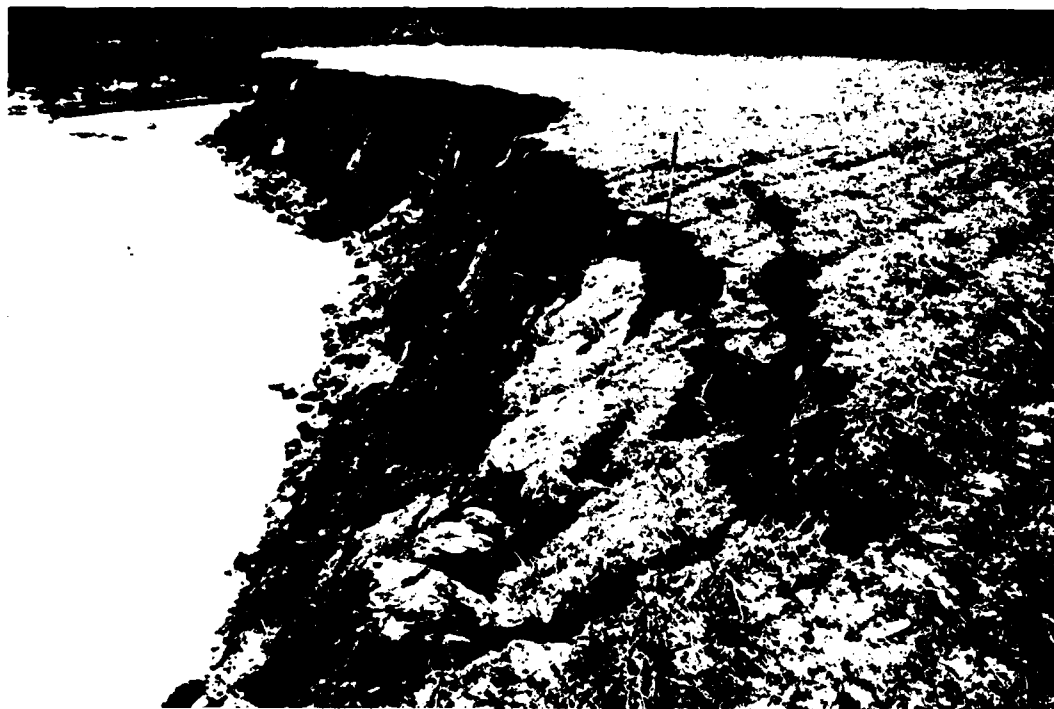
Figure 6. Imminent Slab Failure observed on Goodwin Creek at Katherine Leigh site, Panola County.

Observations of bank erosion and failure in the bluff line streams made by the Channel Stability Research Unit of the Sedimentation Laboratory over several years, and by the authors in a preliminary field survey in the fall of 1979, confirmed that slab failure is the dominant failure mechanism (Fig. 6. and 7.). Unstable banks show deep tension cracking prior to shear failure. Tension cracks develop from the ground surface down, almost parallel to the bank line. Often they seem to begin during a dry period that produces shrinking and cracking in the soil. They further develop mostly during wet periods, owing to the increased weight of the soil, which tends to pull the crack open. The passage of water down the tension crack

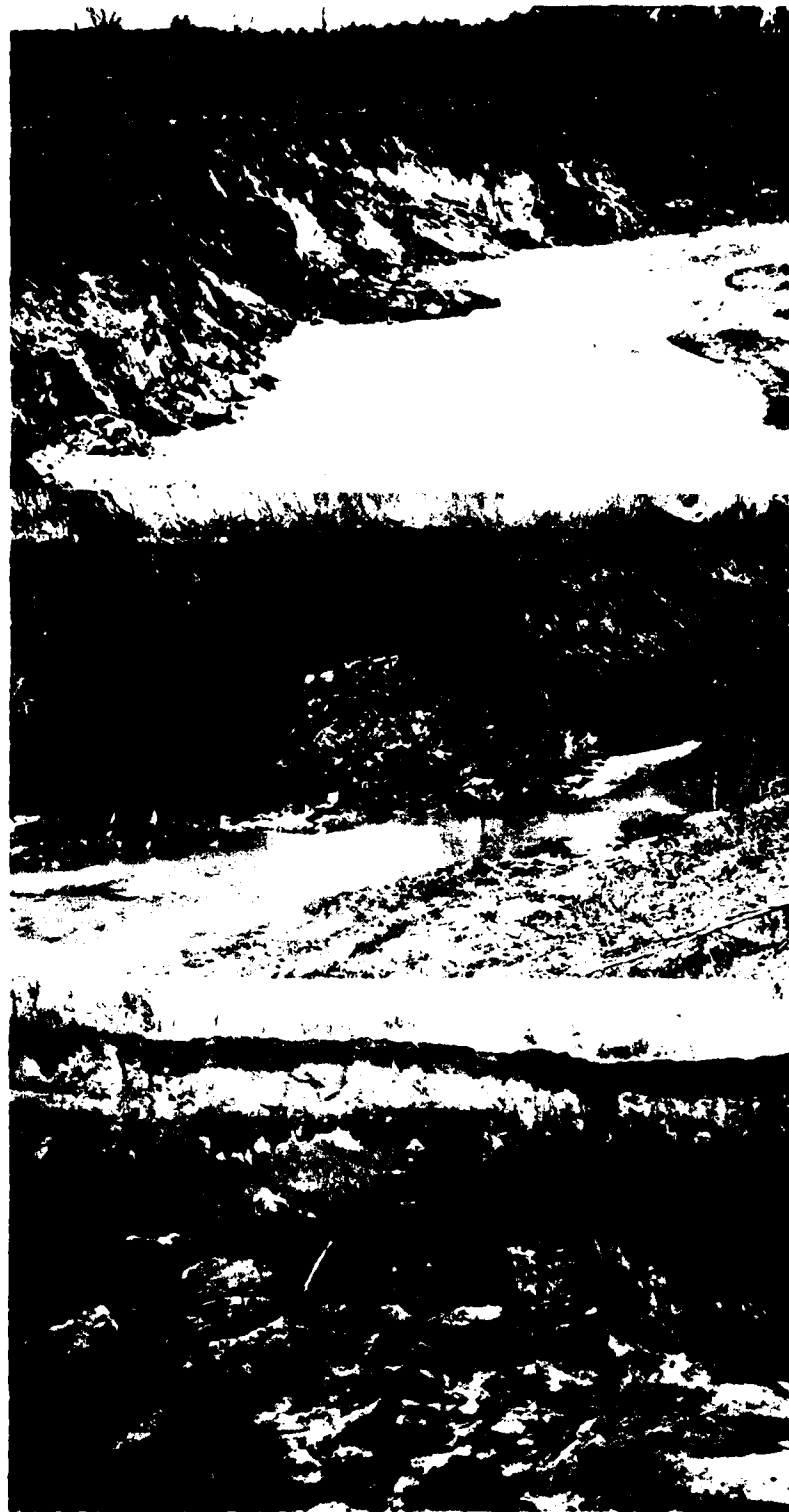
Figure 8. Slab failure with a) more or less intact failure block, b) disintegration of failure block into a soil fall and c) disintegration of failure block into a soil flow.

Shear failure slip surfaces are slightly curved. The degree of curvature of the slip surface, and the width of the failing block, together control whether blocks topple forwards into the channel, slide outward and downwards, or rotate with back tilting of the upper surface. Depending on the strength, fabric, and internal stress distribution of the failing block, it either remains more or less intact or disintegrates into a soil fall or flow during failure (Fig. 8.).

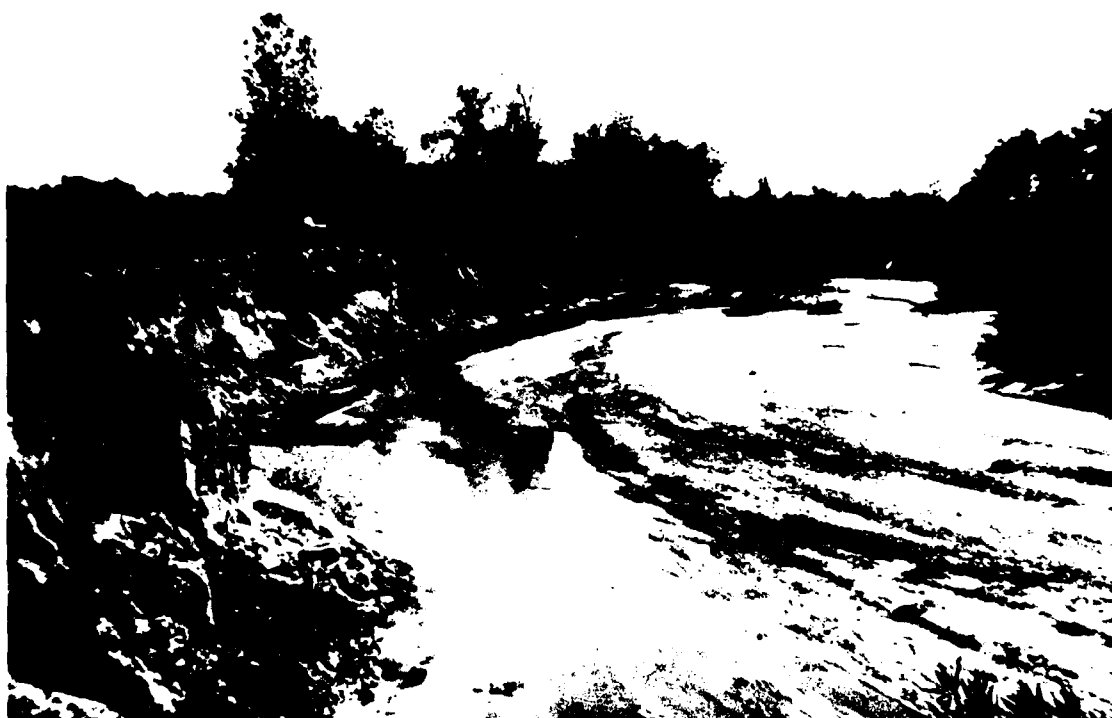
Figure 17. View of Tommy Florence's Site showing eroding bank located at the outside of a developing bendway.

In fact the banks at T.F.'s were stable throughout the summer of 1980 when the soil data were collected and this bears out the fact of plots of bank angles falling well below the critical line for mean conditions. Historically the left bank is known to be retreating rapidly, so the instability indicated by the analysis is real. Also, field observations show as predicted here, that most retreat takes place by mass failures during or after storm events in winter or spring. Then, to some extent the analysis and interpretation are confirmed. However, further resurveys and site monitoring are necessary to fully verify the conclusions and predictions.

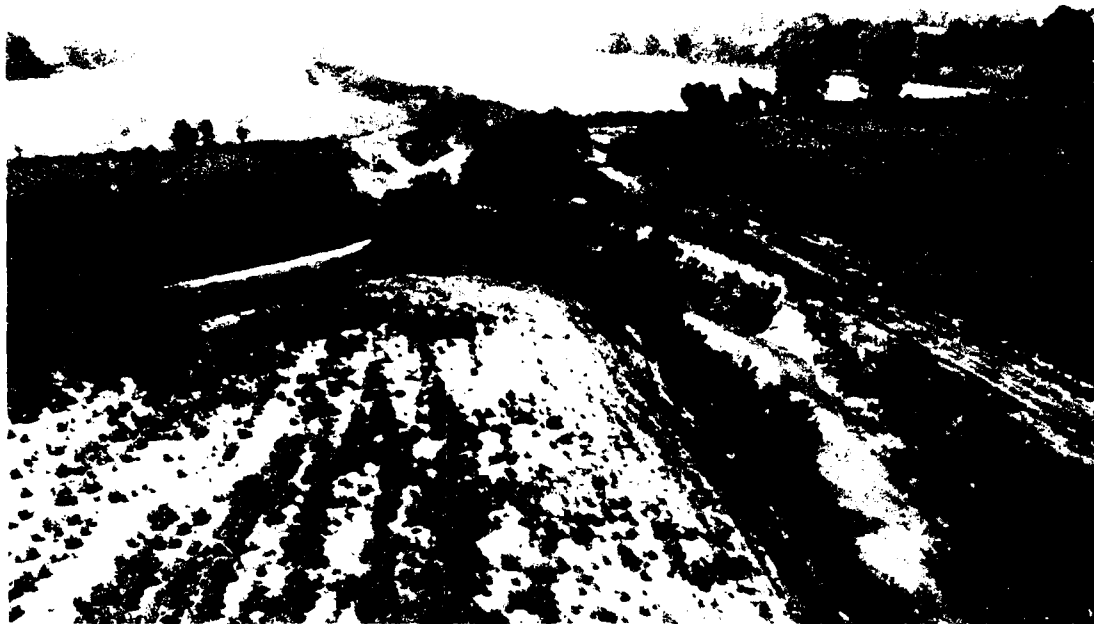
Figure 18. View of T. A. Woodruff's Site showing straight channel and vegetated banks above the headcut (now stabilized by a grade control structure).

In the field it is clear that both banks at sections 1 and 3 are clearly more stable than those at Tommy Florence's. They are fairly well vegetated and show no signs of recent failures. Sections 2 and 4 have one very stable bank (2(L) and 4(R)) and one marginally stable bank (2(R) and 4(L)). In both cases the very stable bank is located behind the point bar while the less stable bank is next to the scour pool. At section 5 the right bank is stable but the left bank is unvegetated and appears to be potentially unstable. These observations support the stability analysis, interpretation and the conclusions drawn by the authors. Like Tommy Florence's site, T.A. Woodruff's site will be monitored and resurveyed to verify the conclusions and predictions.

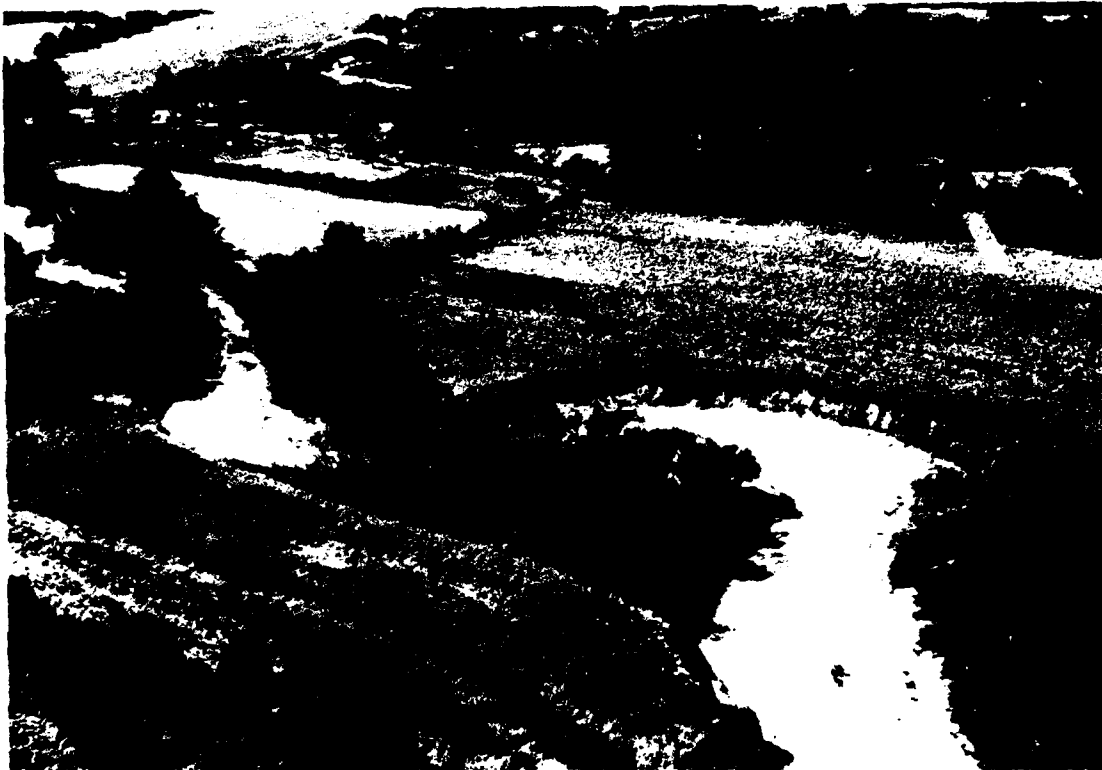
Figure 19. View of Katherine Leigh's Site showing eroding bank on the outside of a developing bendway and resistant materials at section 3.
